**CX22™  
TRAKBALL  
FIELD SERVICE  
MANUAL**

FD100660

REV. 01

November 1983

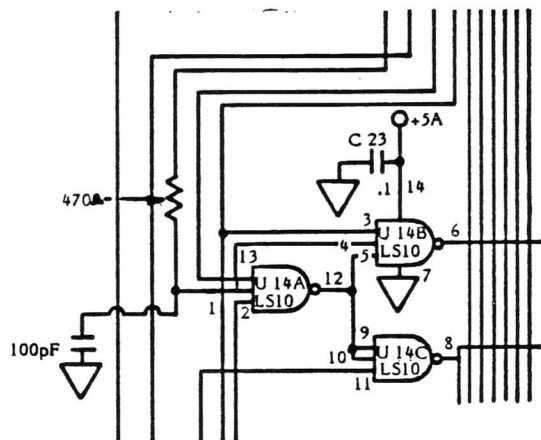
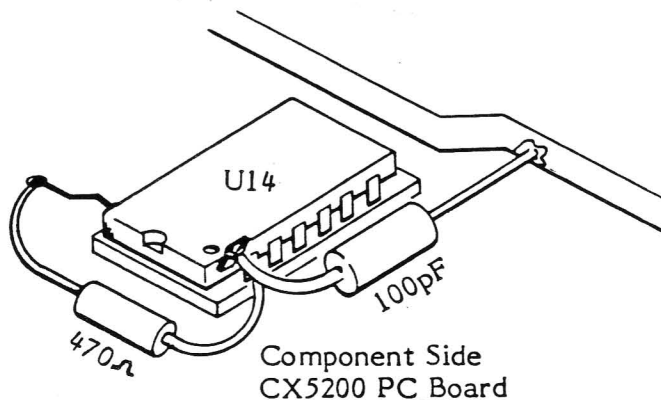
Rockwell MPUs with date code of 8250 and later (stamped with the letters RC) have a timing defect.

A factory modification adds an R-C network on the component side of the CX5200 PC Board at IC U14A (pin 1) and U6A (pin 4) (see Figures 1 and 2).

**Note:** You do not need to remove this network to use any other manufacturer's MPU or a Rockwell MPU with a different date code.

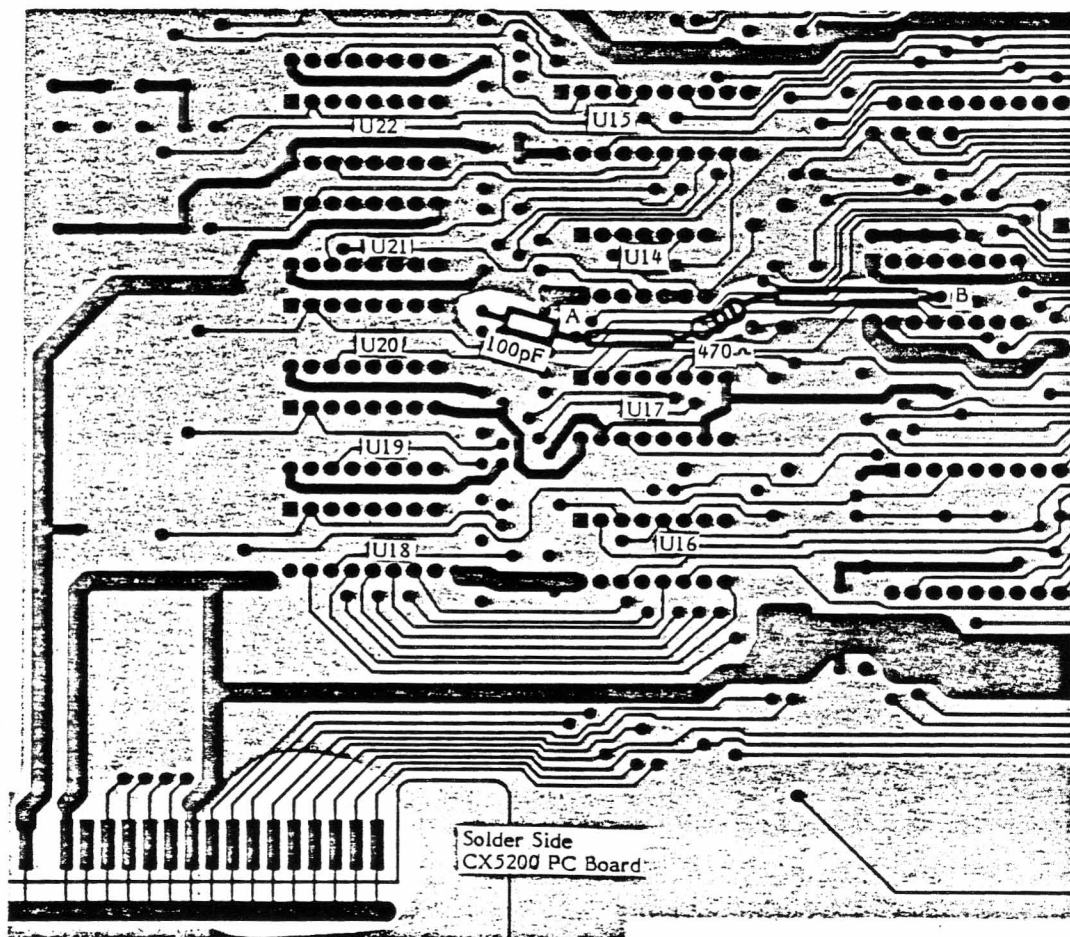
Figure 3. R-C Network (Add to solder side of CX 5200 PC Board)

If you are installing an RC stamped 6502 on a CX5200 PC Board which has not had the factory modification added to the component side:

Add an R-C network to the solder side of the PC Board (See Figure 3).

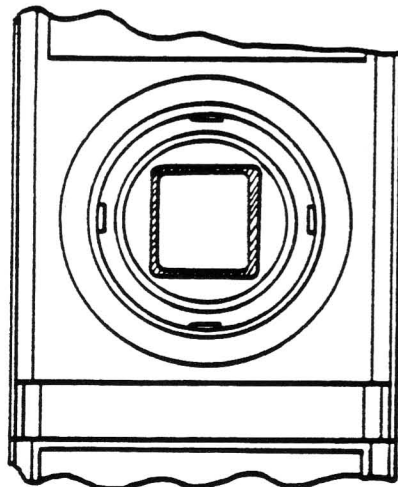
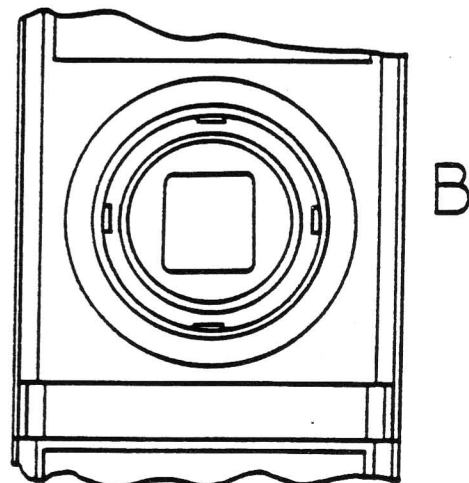
Repair CX5200 Controllers with damaged boots in the following manner:

- 1) Follow Disassembly instructions for the CX5200 Controller in the CX5200 Field Service Manual.
- 2) Remove the top controller case and pull off the joystick handle.
- 3) Remove the boot retaining ring. Remove and discard the damaged boot.
- 4) If the top controller case contains the square ridge around the access well, as illustrated in "A" below, remove and discard it. Replace it with the new top controller case in which this square ridge has been removed, as illustrated in "B".

- 5) Insert new boot, retaining ring, and joystick handle.
- 6) Reassemble controller according to the instructions in the CX5200 Field Service Repair Manual.

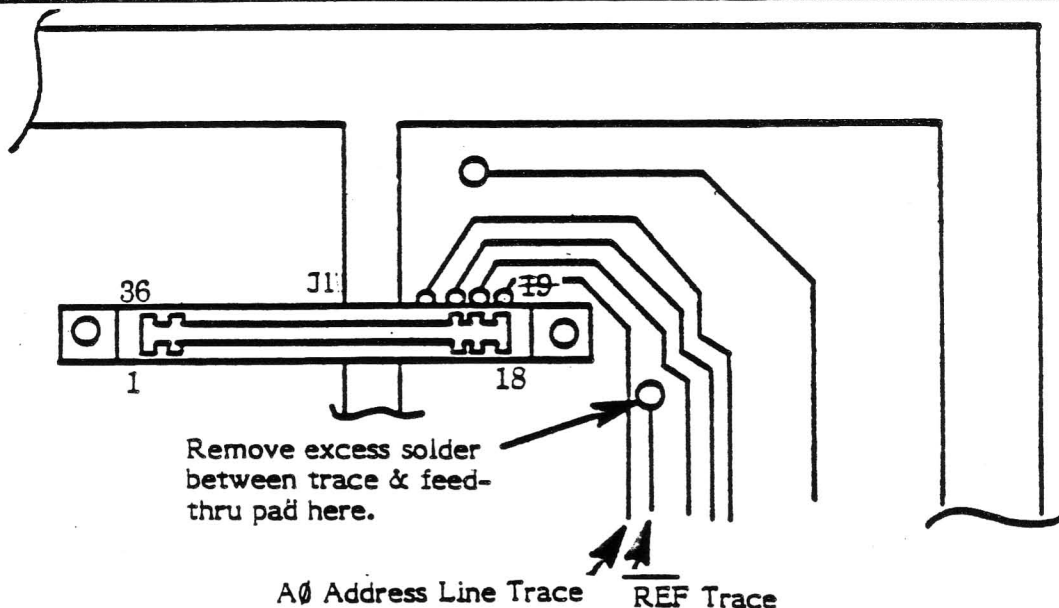
Figure 1. 5200 PCB Solder Side at J1

Some 5200 units display a blank dark screen or a screen with garbled information. The probable cause for either of these symptoms is an intermittent solder short (bridge) on the PCB between the A0 Address line trace and the feedthru pad of the REF Line trace (near connector J1).

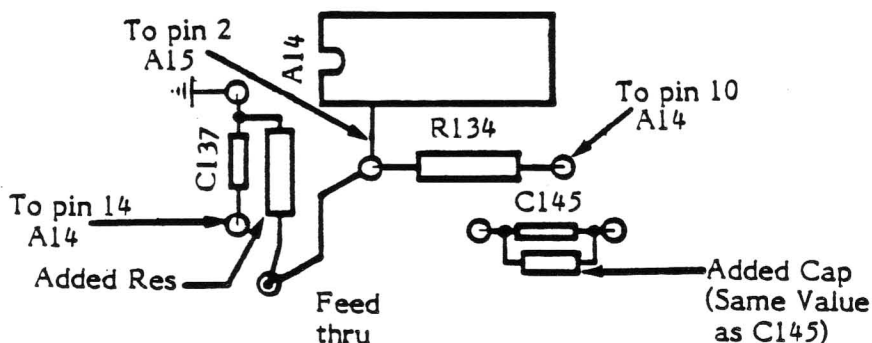
Figure 1. Resistor/Capacitor Fix

The timing of some Signetics I.C.'s causes RAM information to be distorted. This results in a scrambled screen display or worse - no video at all.

C145 (C014179-24) should be paralleled with another 390pf capacitor (C014179-24) and a 470 Ohm resistor (14-5471) be added from C137 to R134 (See Figure 1).

If the unit still displays a faulty screen, swapout A16 and A17 with another vendor's component. DO NOT USE A SIGNETICS I.C.

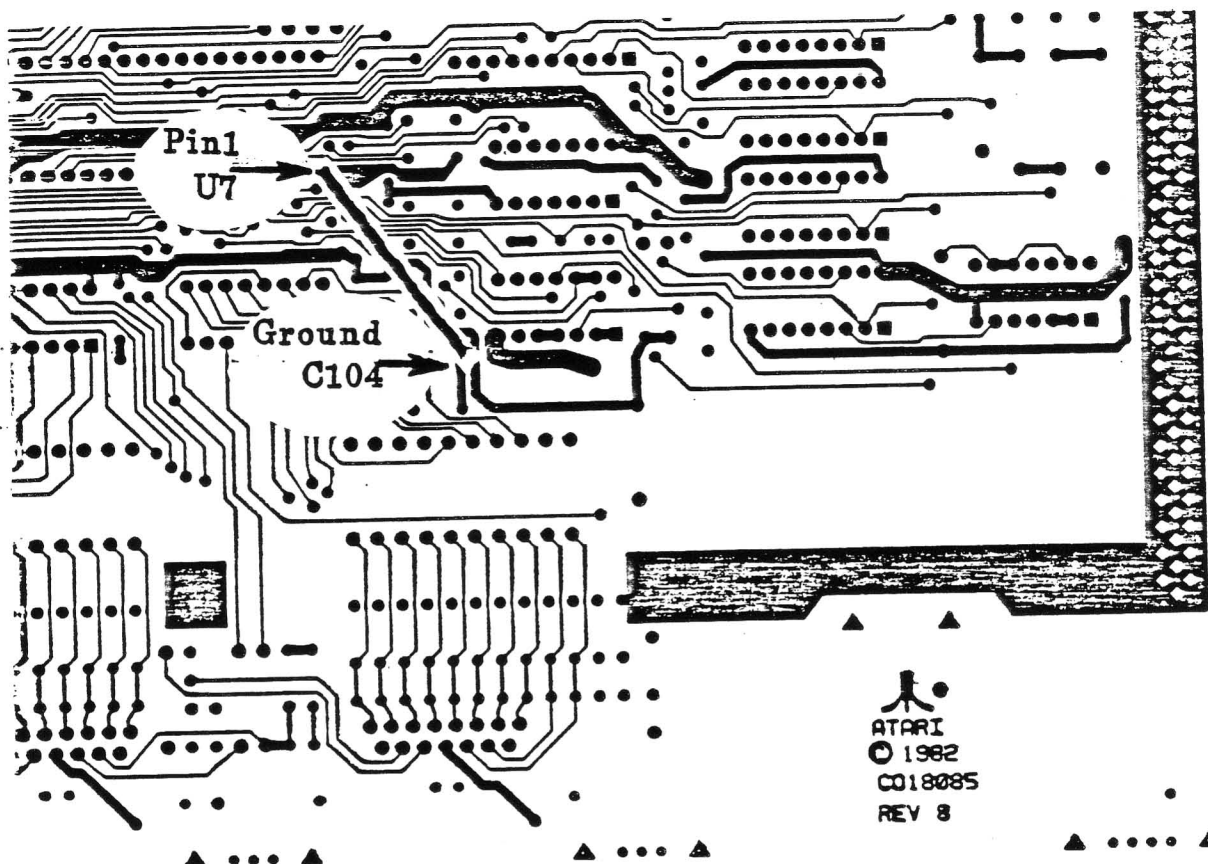
Figure 1. Sleeve Buss Wire Placement

Some 5200 PCB's demonstrate paddle jitter caused by a ripple on the +5v power supply to the POKEY IC (U7), and an inadequate ground trace at Pin 1 of U7.

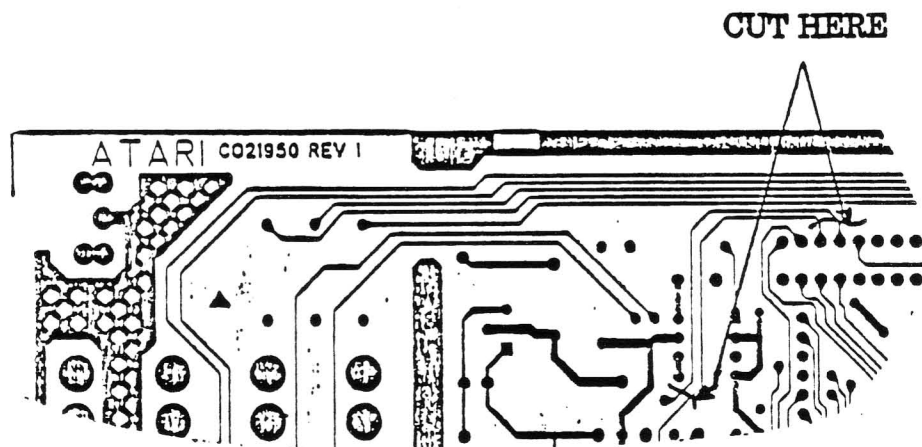
Figure 1. Trace Cuts

NOTE: Some CX55's may have been modified during production. Use these procedures to make certain the jumpers have not become detached.

1. On the solder side of the Adaptor PCB, carefully cut the traces shown in Figure 1.
